STS-107 Flight Readiness Review

Space Station and Payloads Processing **STS-107**

SPACEHAB-Research Double Module FREESTAR

STS-107 (BI116) FLIGHT READINESS REVIEW

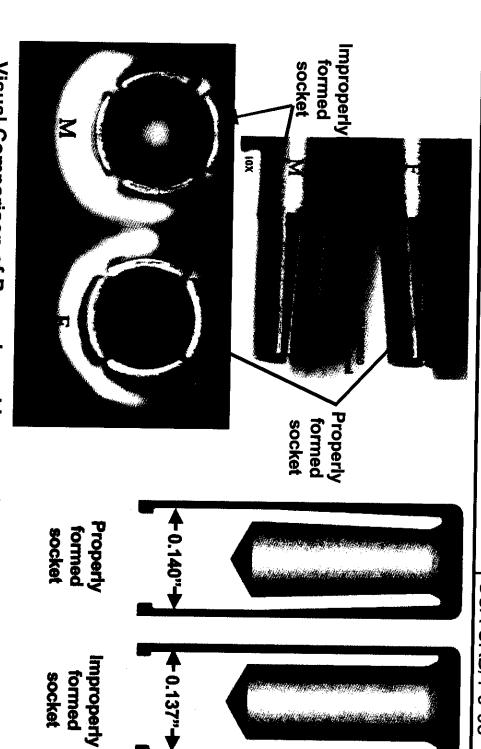
Visual Comparison of Properly and Improperly Formed Sockets

- Formed joint anomaly resolution team
- Representatives from MSFC, USA and Amphenol
- Identified connector socket manufacturing anomaly
- forming of socket Undersized socket barrel outside diameter resulted in improper
- Machined by Amphenol at Sidney NY facility (October 1997)
- In-process inspection
- Operator required to verify six per hour (approximately 10%)
- Contact sockets and hoods shipped to Nogales, Mexico facility for final assembly/inspection and lot acceptance testing
- 100% burnished and gauged manual operation
- Required to perform separation force test on entire lot
- Final lot acceptance testing at 1% Acceptance Quality Level (AQL) First time Nogales facility used for final assembly process
- No changes to assembly process paper
- Language barriers existed during first time operation
- Process paper unclear
- On-site support not provided

- Identified improper machining of socket as primary root cause ot anomaly
- Identified quality escapes as secondary root cause
- In-process checks six per hour required
- Burnish and gauge operation 100% requirement
- Lot acceptance tests 1% AQL
- Completed inspection and pin retention test of all available hardware
- No discrepancies found on STS-107, inspected 12-18-02
- Replaced two cables on STS-114, inspected 12-16-02
- STS-115 aft boosters still to be inspected and tested
- Identified one unused contact on STS-116 as discrepant on 12-11-02

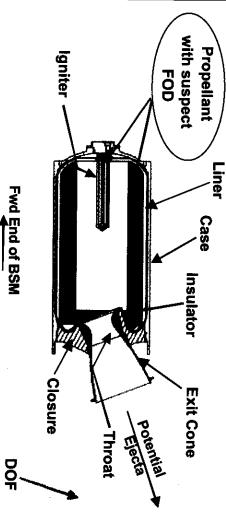
BSM Orientation

Forward BSM Cross Section
